PROPERTY CONDITION REPORT

4140-4146 N. Fremont Ave.
Minneapolis, MN
October 23, 2015
Terracon Project No. F2158516

Re: Property Condition Report
4140-4146 N. Fremont Ave.
Minneapolis, MN 55412
Terracon Project No. F2158516

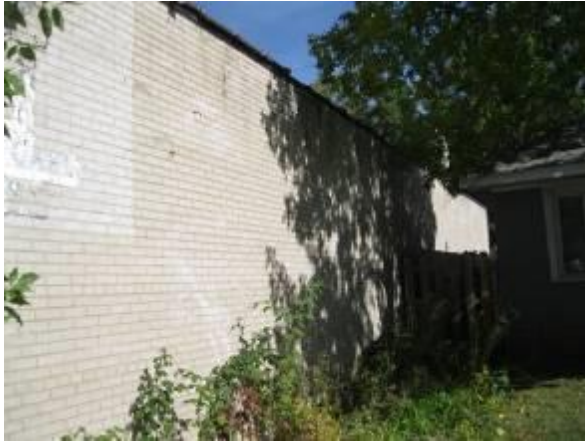
Photo #1 South elevation of 4140/ 4142.

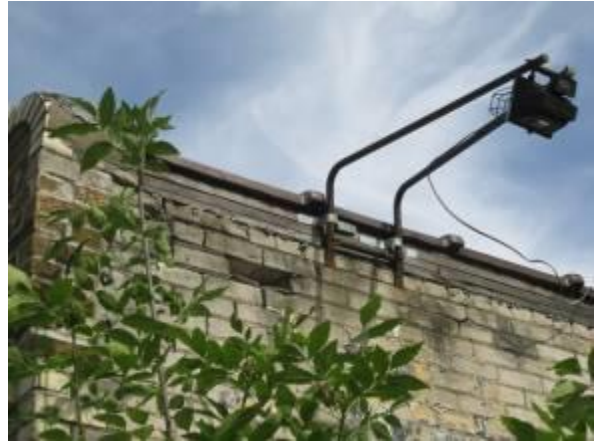
Photo #2 Exposed wood blocking between bell-style copings and south masonry wall.

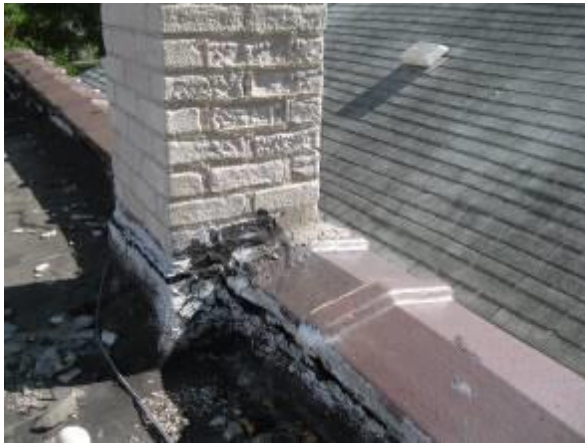
Photo #3 Gap along south parapet at roof flashing.

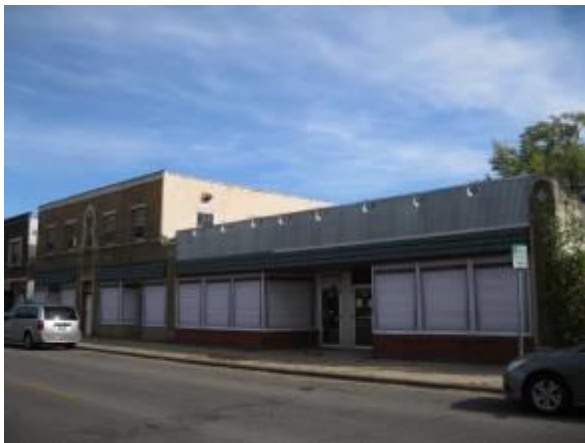
Photo #5 West elevation; 4140-42 (1-story, right half), 4144-46 (2-story, left-half).

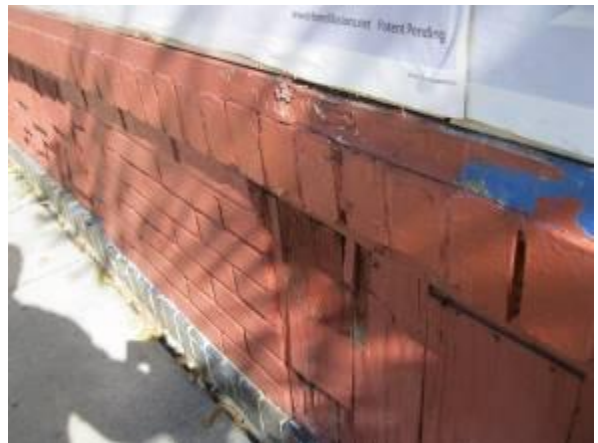
Photo #6 Wood slat in-fill of crawlspace window openings along west side.

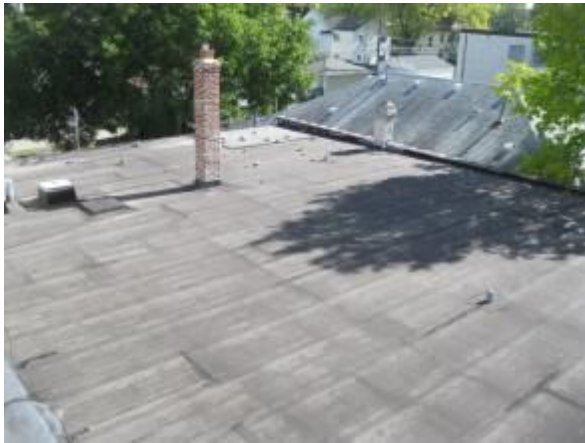
Photo #9 Looking east across the roof over 4140/4142.

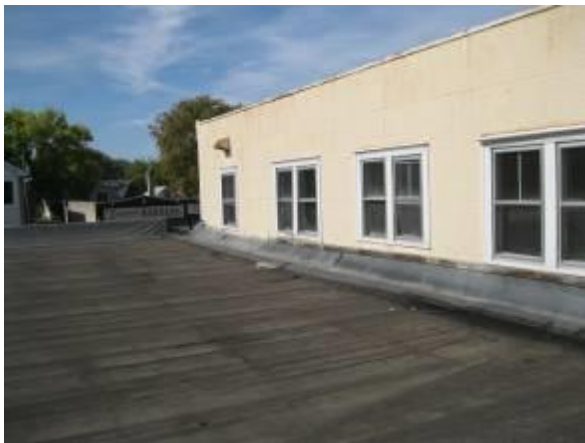
Photo #11 Metal wall panels along the south side of the 2nd level of 4144/4146.

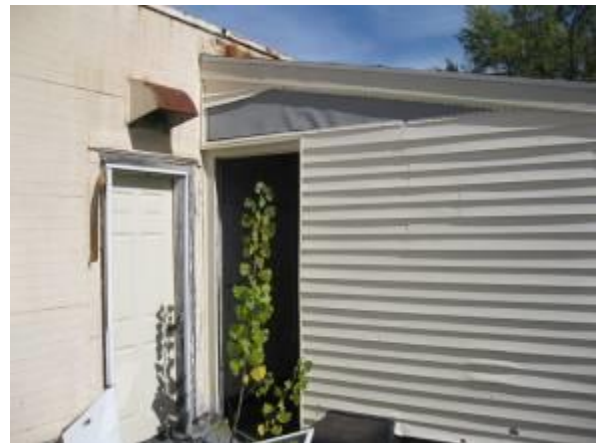
Photo #12 Open, wood-framed structure at the southeast corner of 4144/4146.

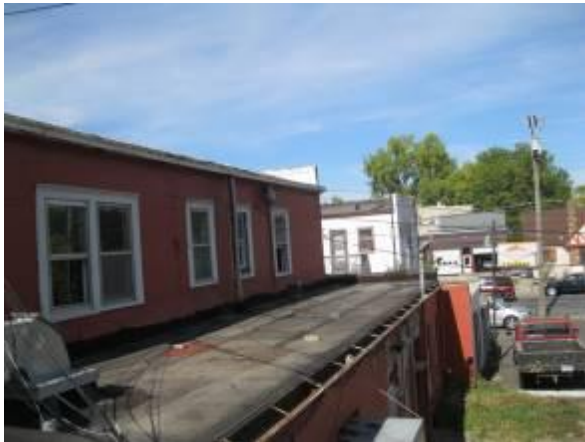
Photo #13 Roof wrapping around rear of 4144-46.

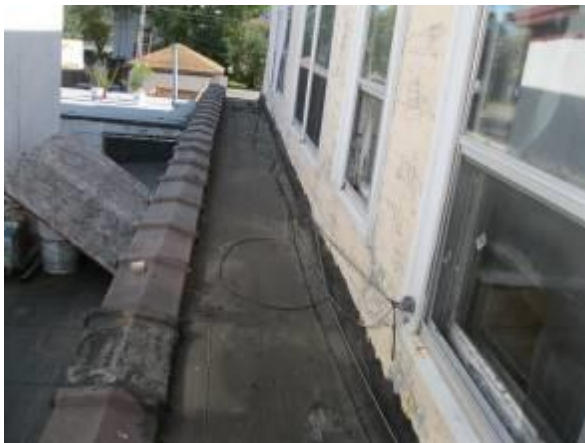
Photo #15 Looking east along the north side of 4144-46 roof after stepping out of 2nd floor window; also shows metal panel exterior.

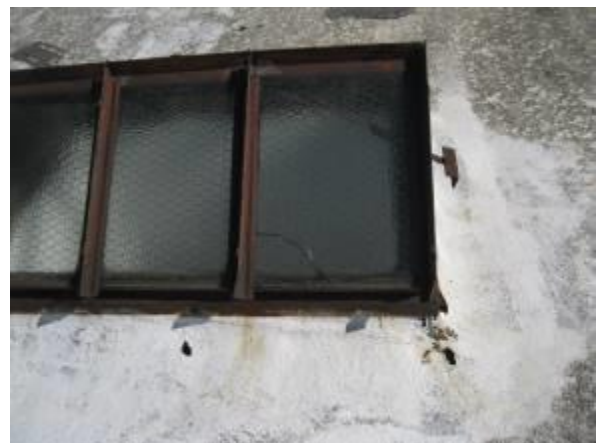
Photo #18 Crack in monitor-style skylight.

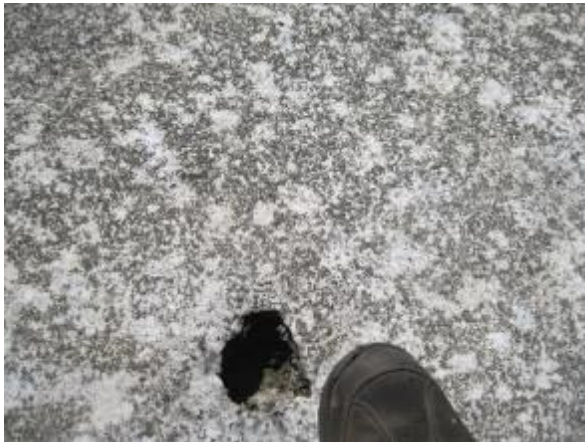
Photo #19 Example of one of many holes throughout the spray-foam roof.

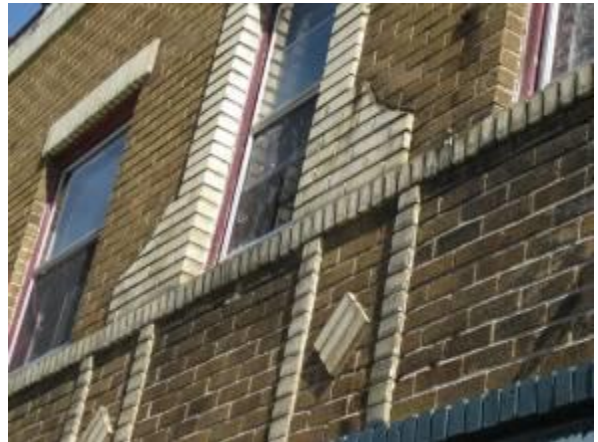
Photo #20 Typical masonry on west (front) side of 4144-46.

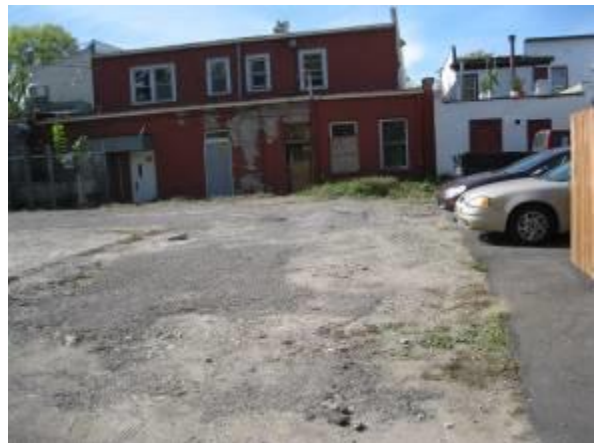
Photo #22 East (rear) elevation along north property line.

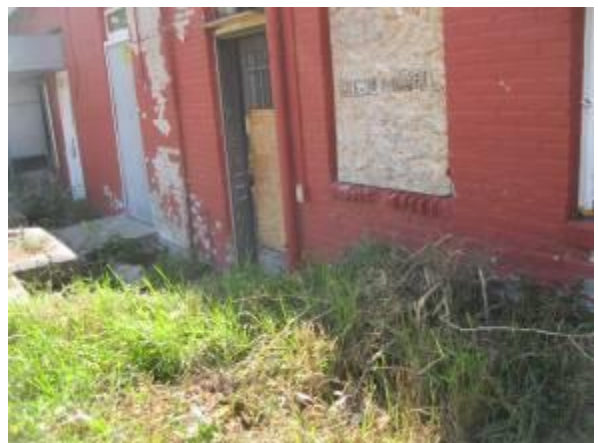
Photo #24 Rear access to 4146 main level.

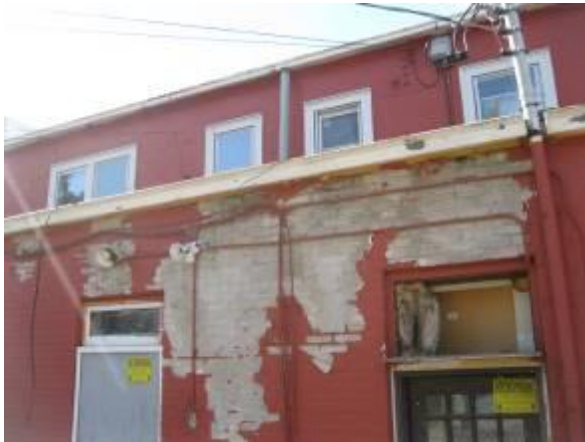
Photo #25 Rear access to 4146 main level (right), 4144-46 rear stairway (left).

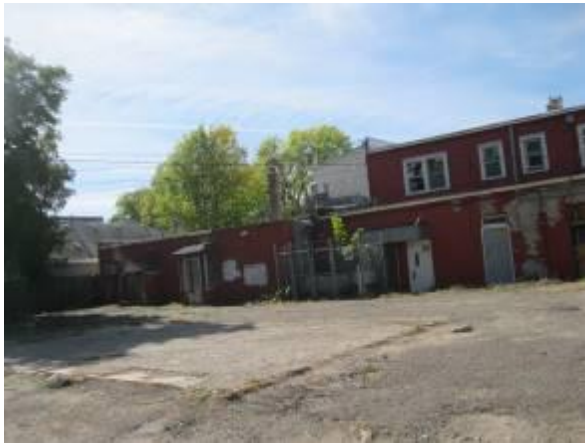
Photo #27 East elevation.

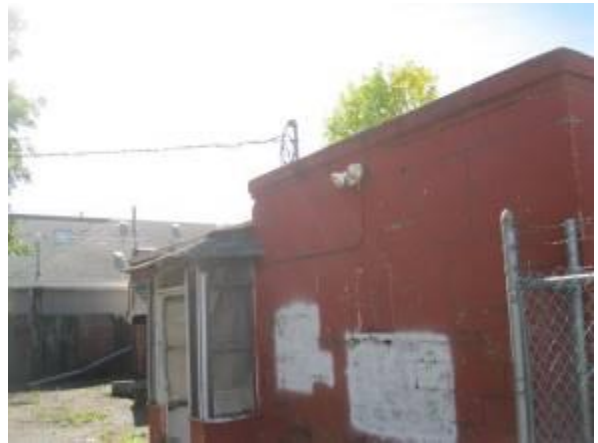
Photo #28 CMU "bump-out" structure at the rear of 4142.

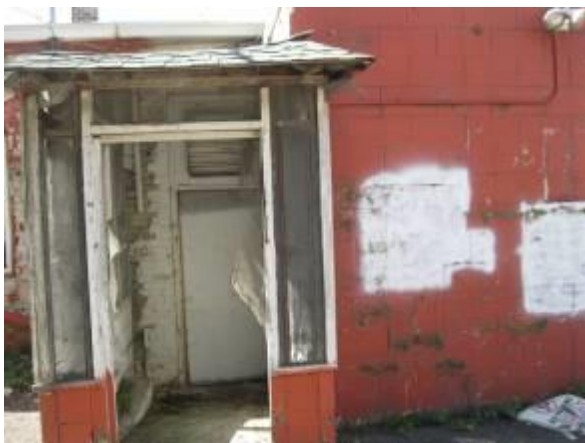
Photo #29 Rear access to 4142.

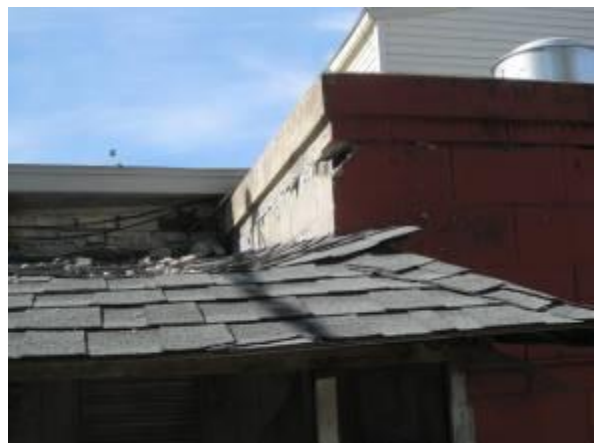
Photo #30 Damaged CMU and roofing above rear access to 4142.

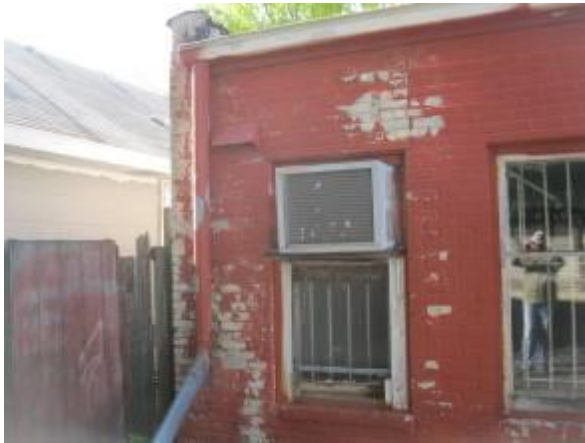
Photo #33 Rear elevation of 4140.

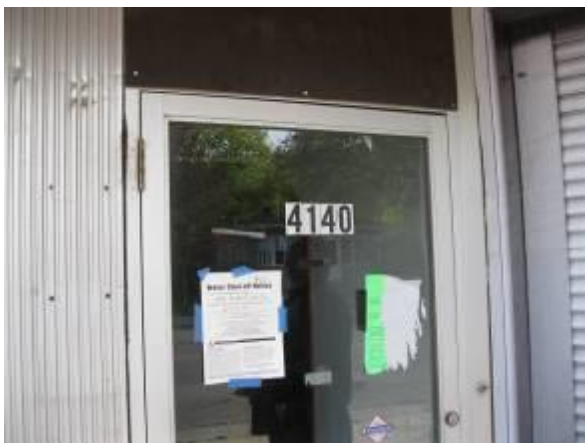
Photo #35 4140 front entrance.

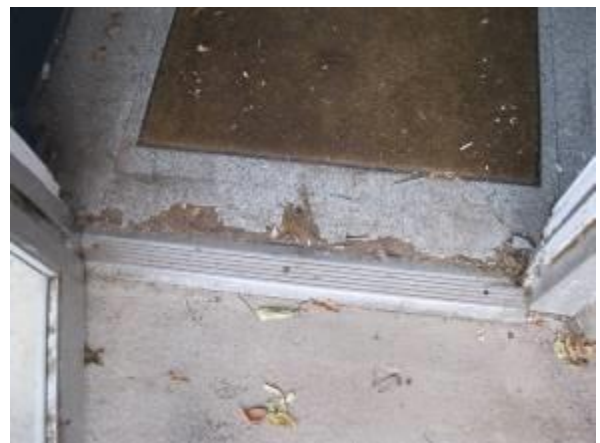
Photo #36 4140 front entrance.

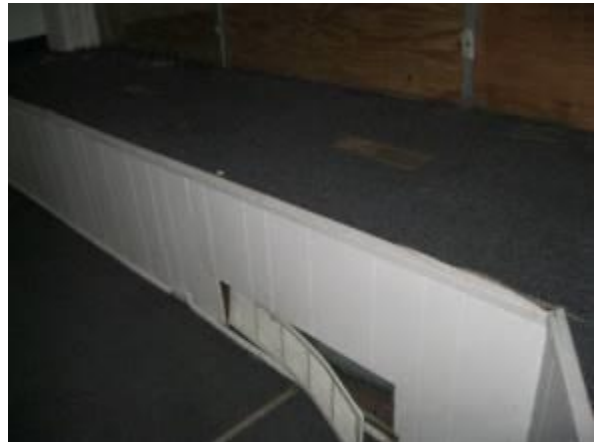
Photo #38 4140- enclosed ductwork above crawlspace.

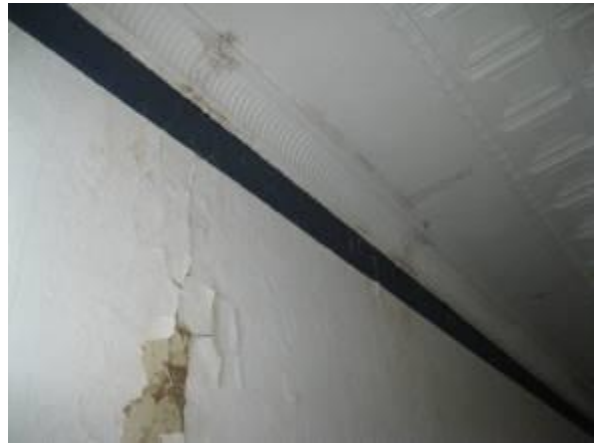
Photo #40 4140- close up of prior photo.

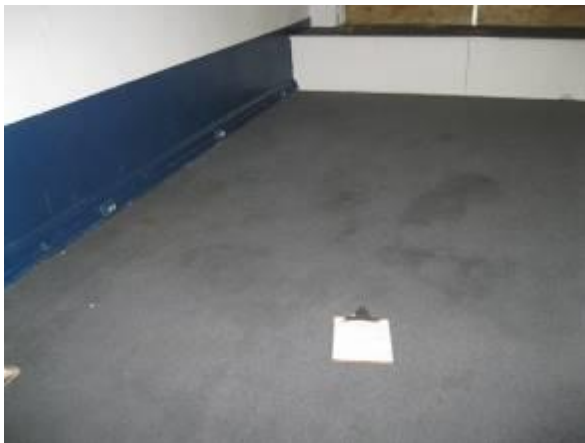
Photo #41 4140- curled floor sheathing in front area.

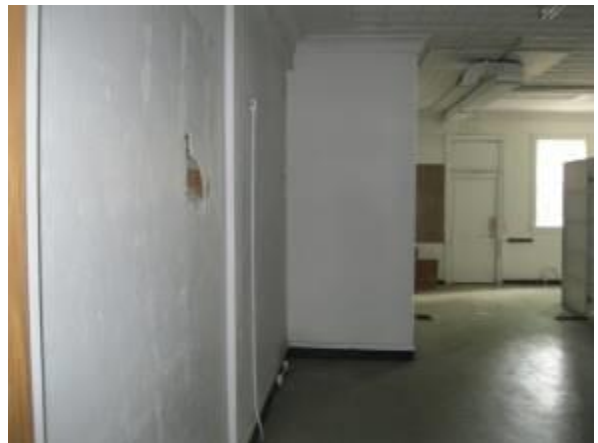
Photo #42 4140- looking towards rear area on main floor.

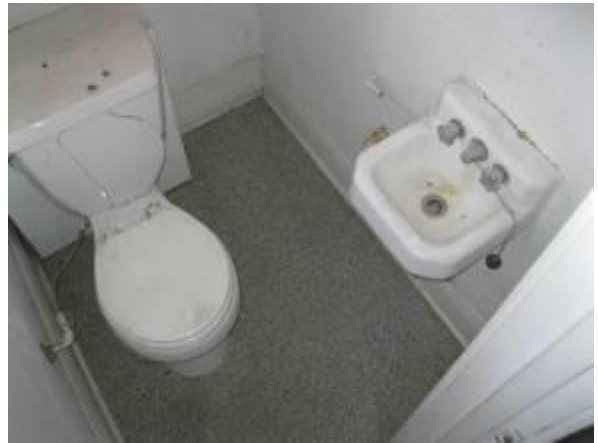
Photo #46 4140- rear restroom.

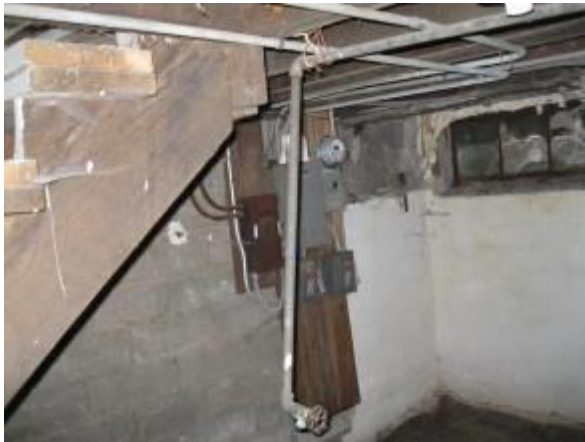
Photo #49 4140- northeast corner of basement.

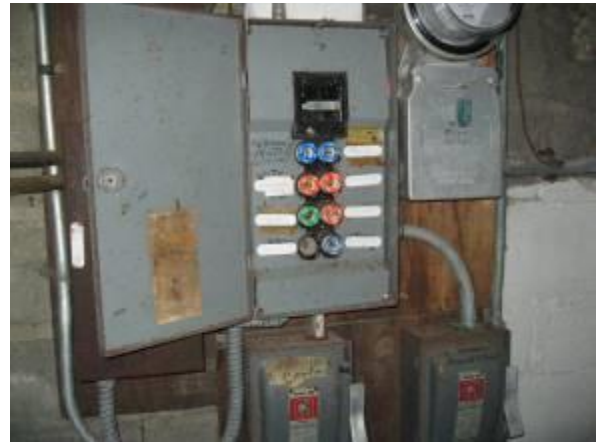
Photo #50 4140- screw-based fuses and *Bulldog* Junior Vacu-Break disconnect switches.

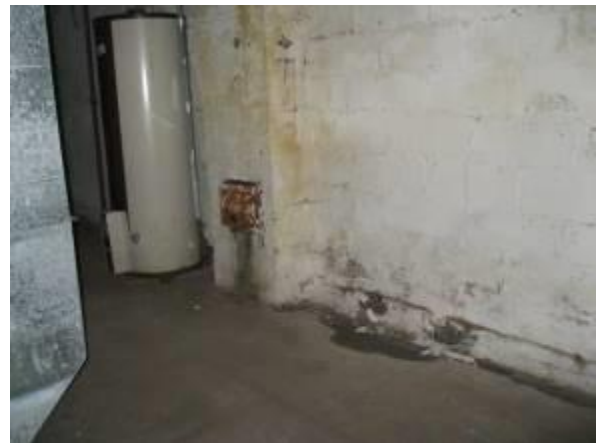
Photo #52 4140- gas-fired water heater along south CMU foundation wall.

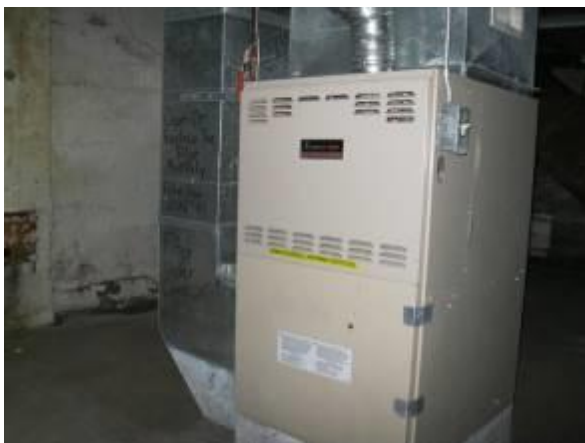
Photo #53 4140- gas-fired furnace.

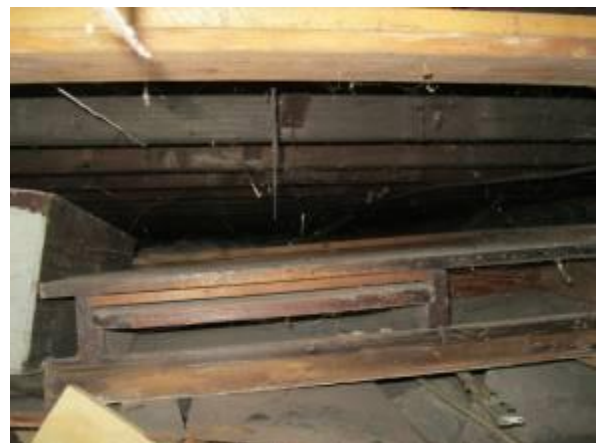
Photo #54 4140- looking west into crawlspace.

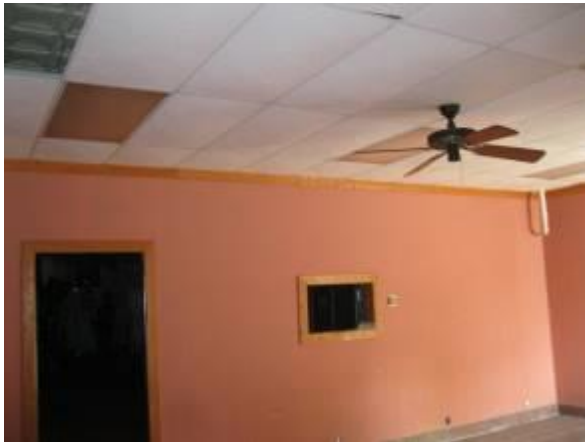
Photo #55 4142- front area at main area.

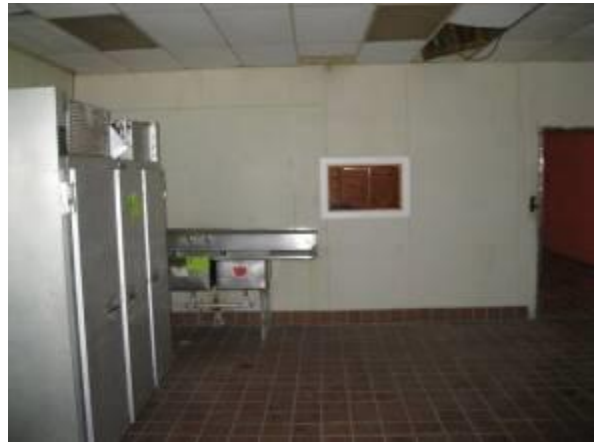
Photo #56 4142- rear, former kitchen space.

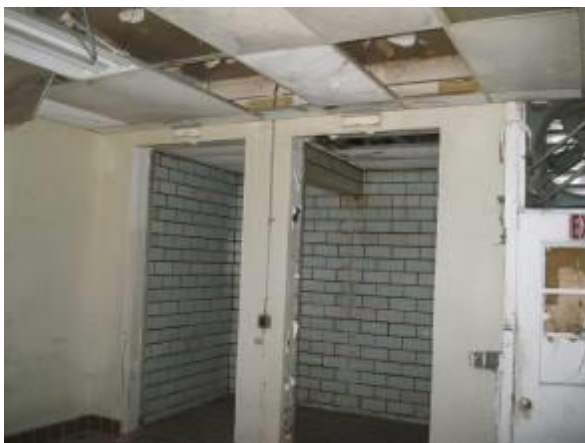
Photo #59 4142- inside the CMU "bump-out" seen on the rear, adjacent to the access door.

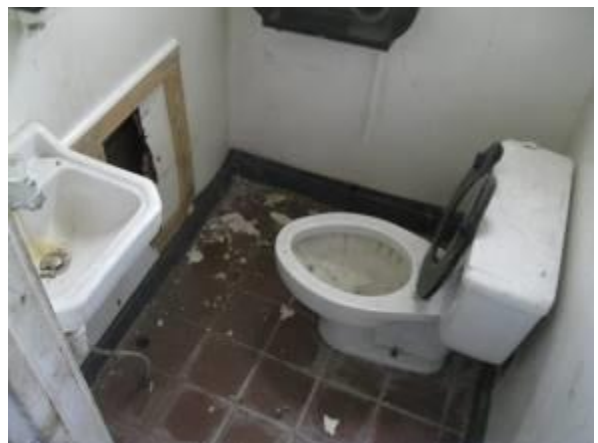
Photo #60 4142- rear restroom.

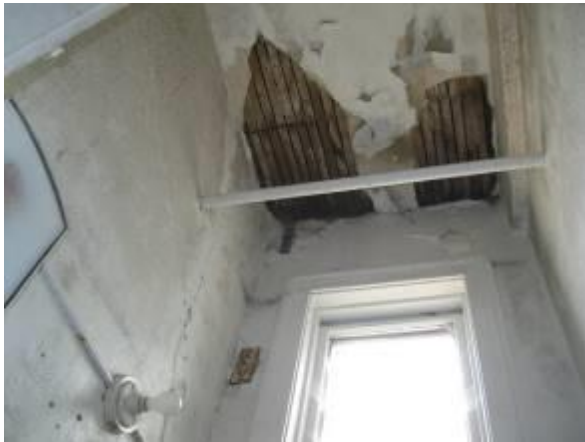
Photo #61 4142- rear restroom.

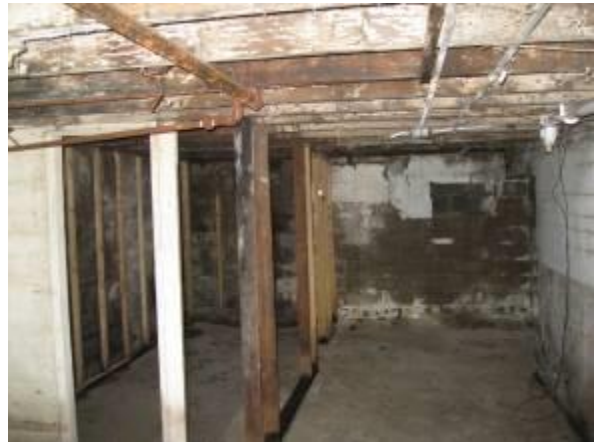
Photo #62 4142- northeast corner of basement.

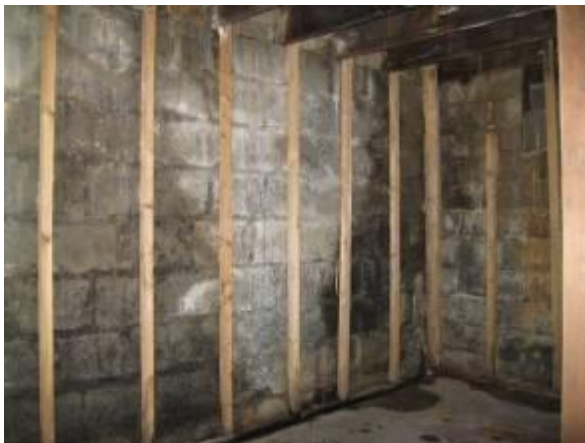
Photo #63 4142- northeast corner of basement.

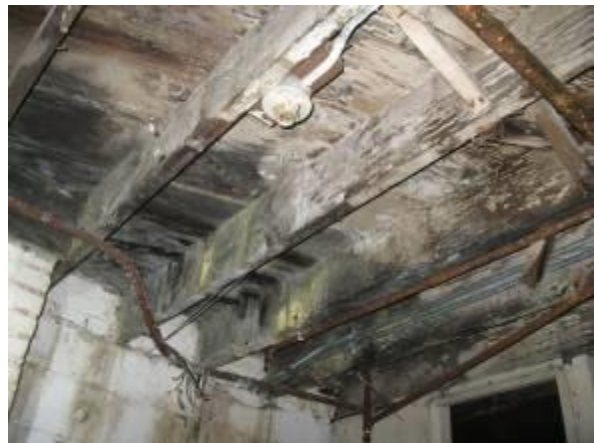
Photo #64 4142- northeast corner of basement.

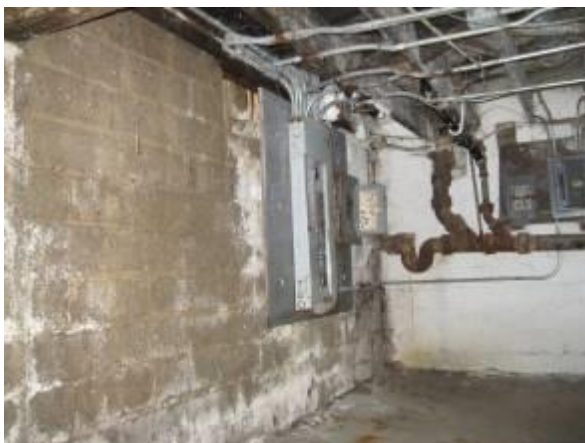
Photo #65 4142- electric in southeast corner of basement.

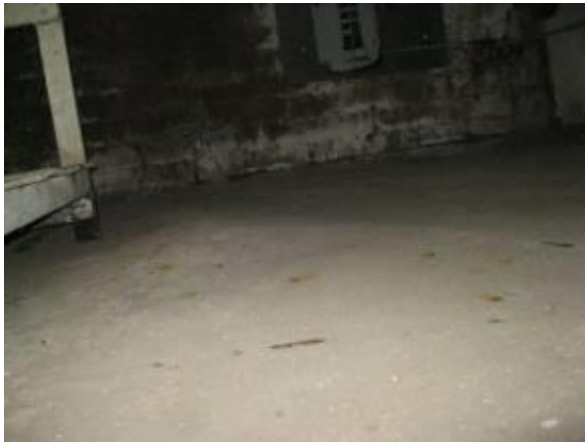
Photo #67 4142- ridge in concrete slab near rear/ east end of basement.

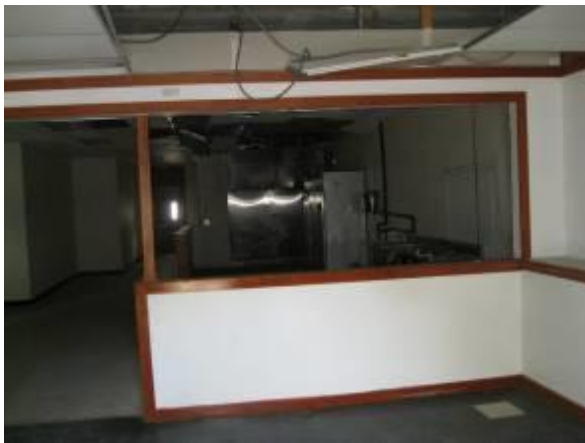
Photo #69 4144- looking rear/ east towards former kitchen space.

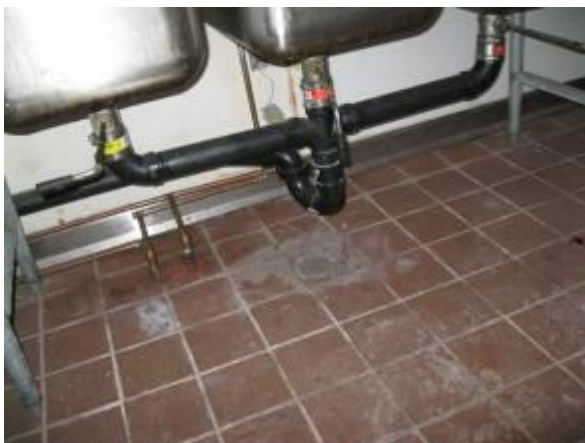
Photo #71 4144- ABS drain pipe on south wall.

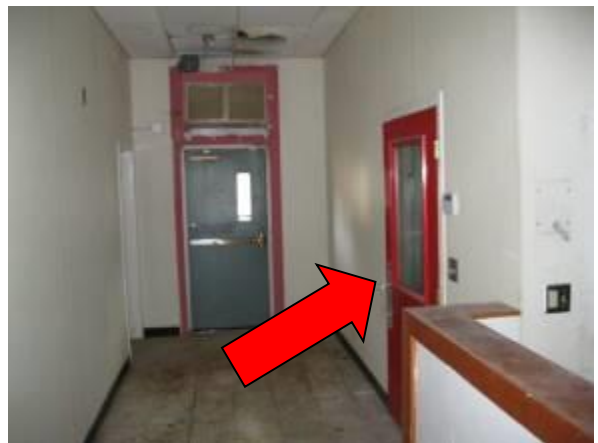
Photo #72 4144- rear access door (arrow refers to opposite side of wall in next photo).

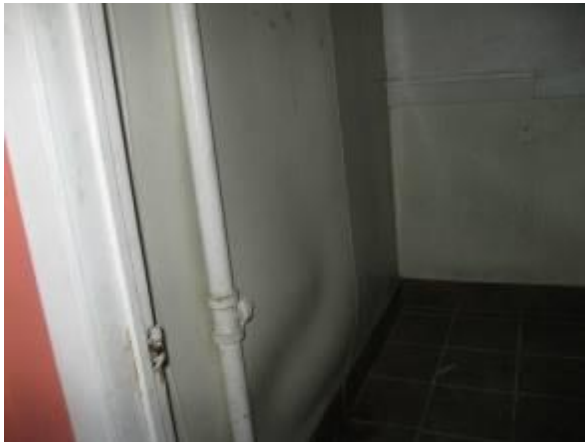
Photo #73 4144- heavily buckled FRP on opposite side of south wall adjacent to rear access hall (see arrow in prior photo).

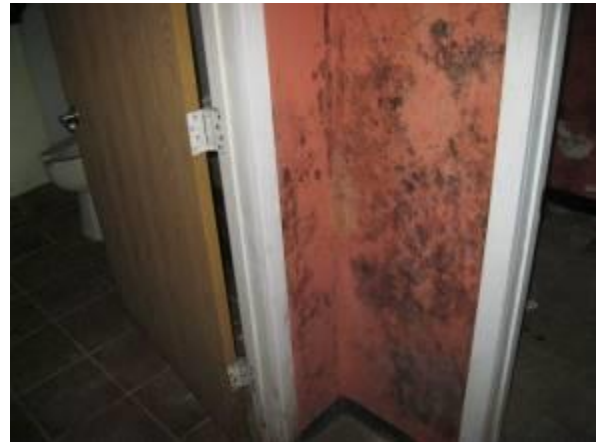
Photo #74 4144- mold on rear walls near restroom.

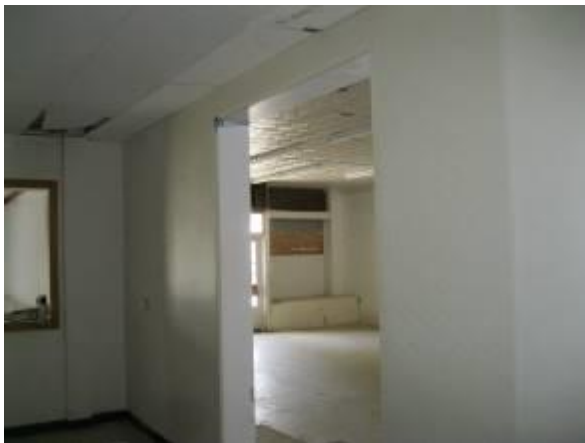
Photo #75 4146- looking northwest into front area of main level of 4146.

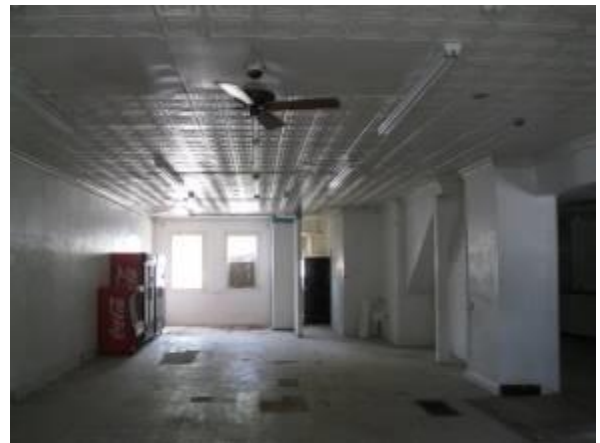
Photo #76 4146- rear area.

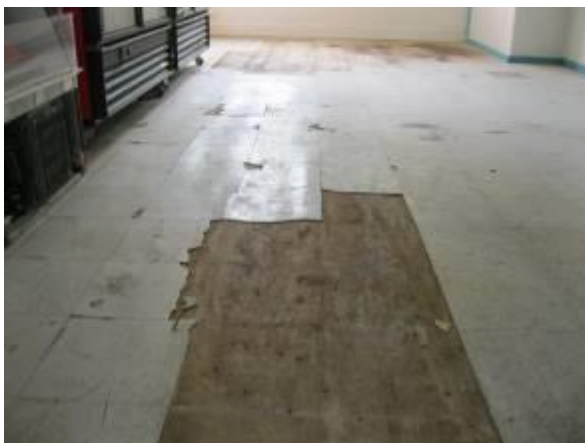
Photo #77 4146- buckled floor sheathing in rear area.

Photo #79 4146- stained basement ceiling below warped sheathing observed in photo 77.

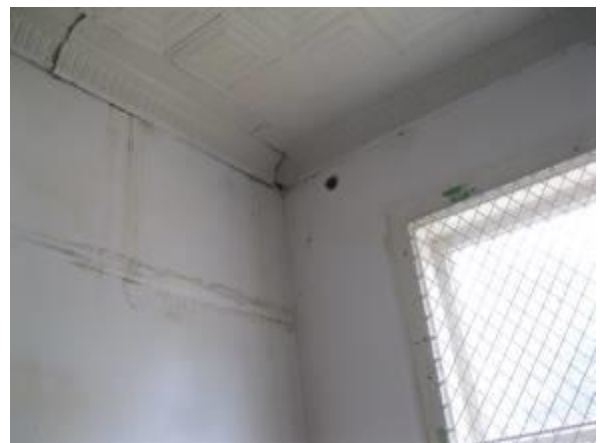
Photo #78 4146- evidence of moisture infiltration in northeast corner.

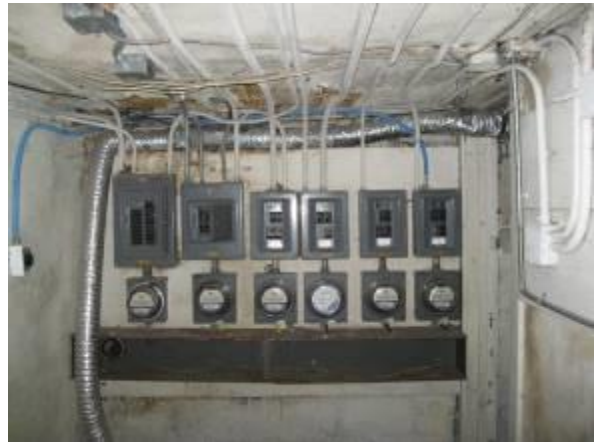
Photo #80 4146- separate tenant meters for two units on the main floor (4144 & 46) and four apartment units on 2nd floor.

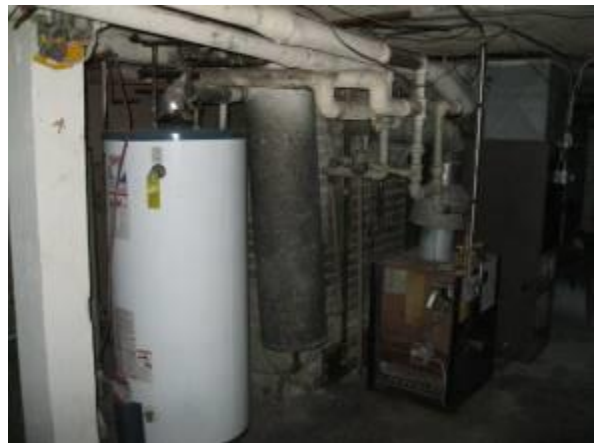
Photo #84 4146- one, each, water heater, boiler and furnace; matching units (except boiler) on other side of wall serving 4144.

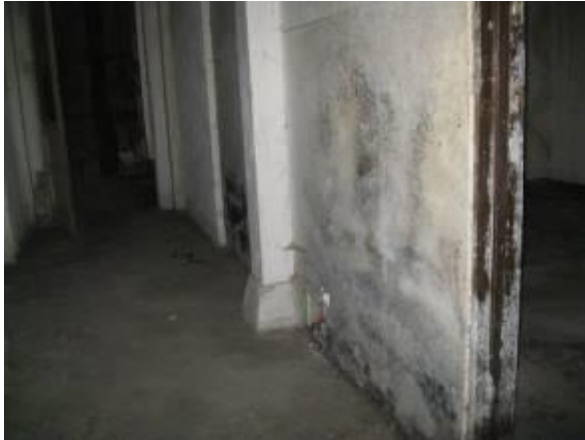
Photo #85 4144-46- mold on rear demising wall in center of basement.

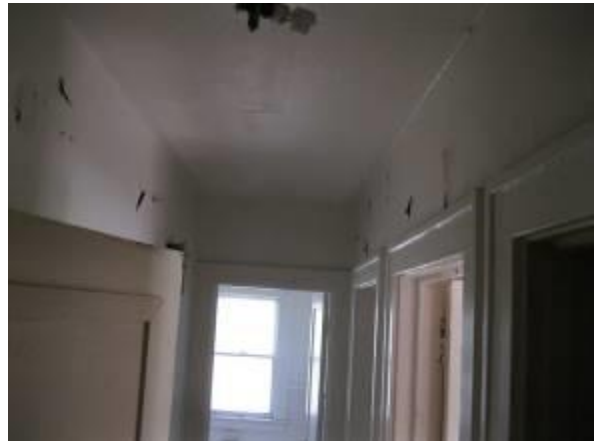
Photo #88 4144-46- looking east through rear/central hallway.

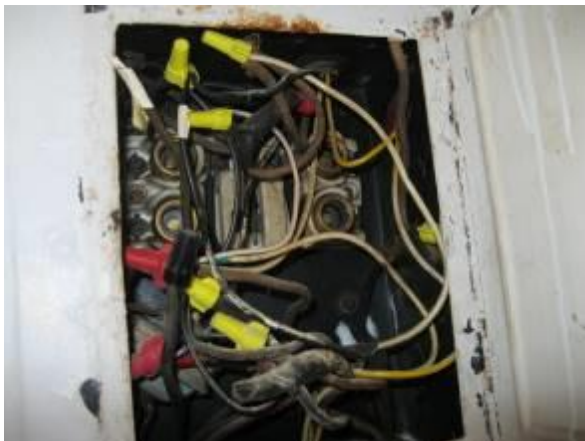
Photo #89 4144-46- open screw-based fuse box high up on hallway wall.

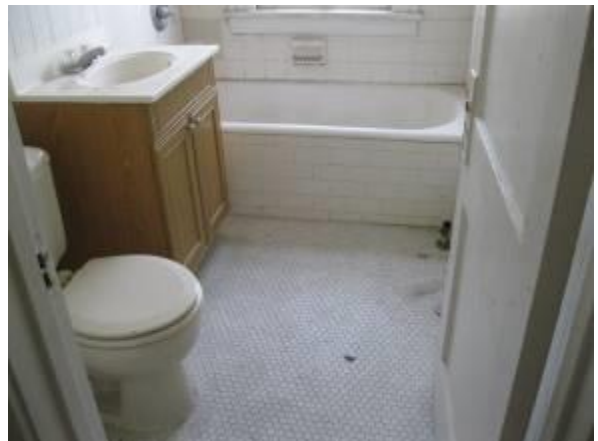
Photo #90 4144-46- example restroom.

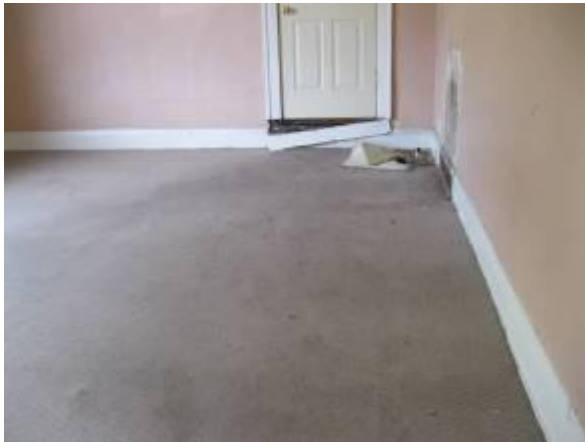
Photo #91 4144-46- southeast corner bedroom.

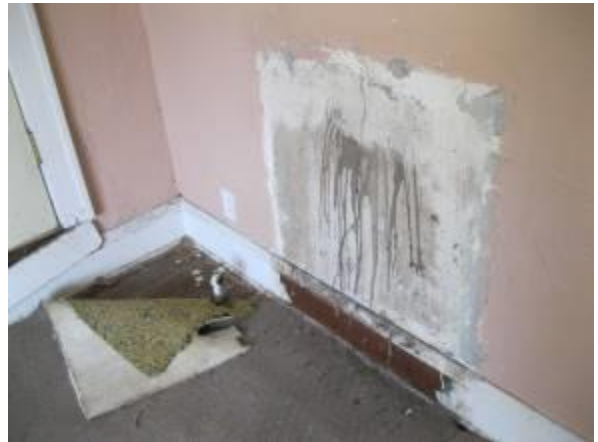
Photo #92 4144-46- southeast corner bedroom.

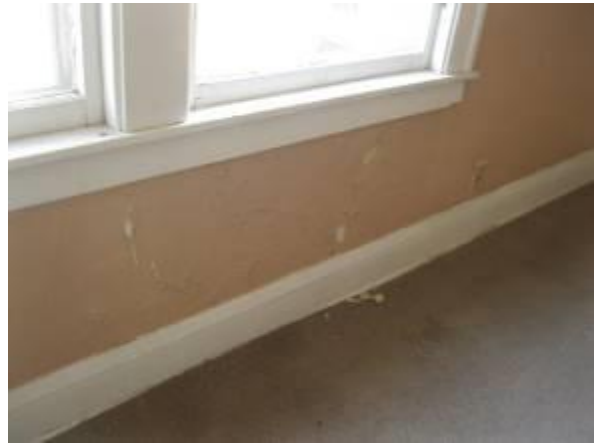
Photo #94 4144-46- southeast corner bedroom; peeling paint below windows.

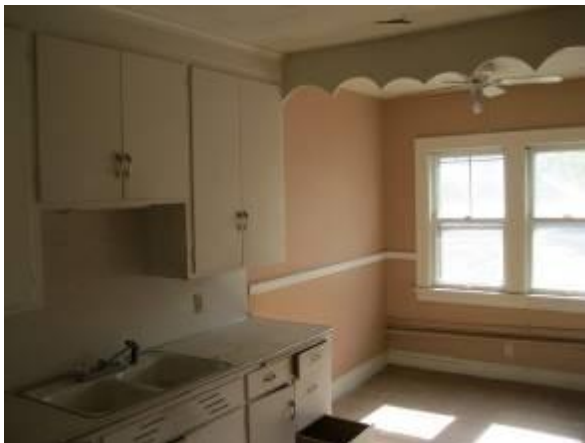
Photo #95 4144-46- south/ central kitchen.

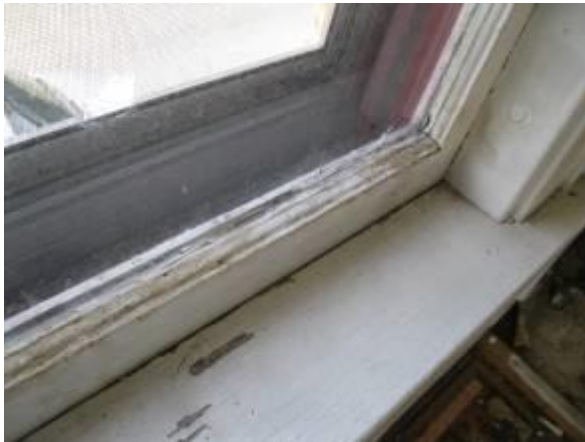
Photo #97 4144-46- typical single-pane, wood-framed windows (some replacement with aluminum-framed units observed).

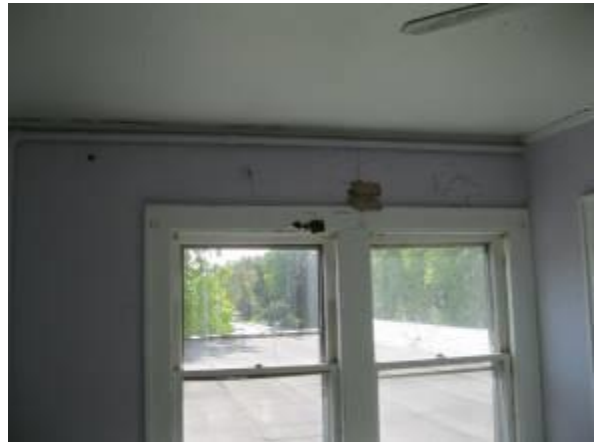
Photo #98 4144-46- southwest corner.

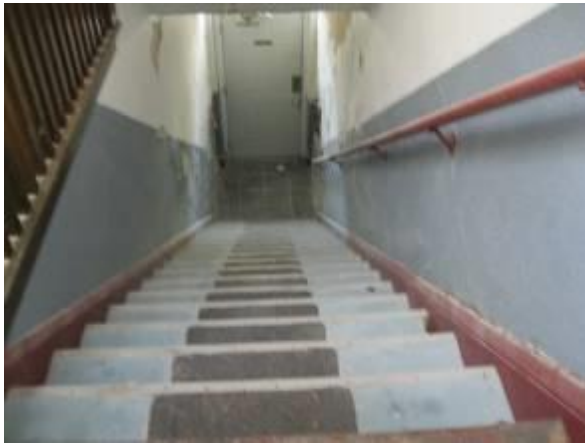
Photo #99 4144-46- front common stairway.
